DEPARTMENT OF TRANSPORTATION**DIVISION OF ENGINEERING SERVICES**

Contract #: 04-0120F4Cty: SF/ALA Rte: 80 PM: 13.2/13.9File #: 1.28**WELDING INSPECTION REPORT****Resident Engineer:** Casey, William**Address:** 333 Burma Road**City:** Oakland, CA 94607**Report No:** WIR-027325**Date Inspected:** 15-Mar-2012**Project Name:** SAS Superstructure**OSM Arrival Time:** 700**Prime Contractor:** American Bridge/Fluor Enterprises, a JV**OSM Departure Time:** 1730**Contractor:** American Bridge/Fluor Enterprises, a JV**Location:** jobsite**CWI Name:** Salvador Merino**CWI Present:** Yes No**Inspected CWI report:** Yes No N/A**Rod Oven in Use:** Yes No N/A**Electrode to specification:** Yes No N/A**Weld Procedures Followed:** Yes No N/A**Qualified Welders:** Yes No N/A**Verified Joint Fit-up:** Yes No N/A**Approved Drawings:** Yes No N/A**Approved WPS:** Yes No N/A**Delayed / Cancelled:** Yes No N/A**Bridge No:** 34-0006**Component:** SAS project**Summary of Items Observed:**

Orthotropic Box Girder (OBG) sections:

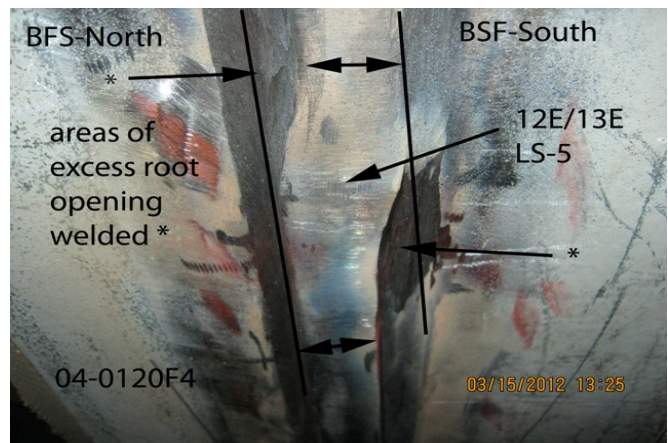
welding personnel Jeremy Dolman (#5042) using the Shielded Metal Arc Welding (SMAW) process to weld the North and South plates. The previous day this QA Inspector observed and documented the excessive root openings during the weld joint fit up of these weld joints. This QA Inspector informed Lead QA Inspector Danny Reyes of the observation that welding was being started prior to the issues being corrected and/or an answer to the pending RFI to be submitted by ABF and was informed to write an Incident Report documenting the issue. This QA Inspector observed QC Inspector Salvador Merino verify the following welding parameters; 127 amperes. This QA Inspector observed an E9018 electrode was being used and verified the preheat was greater than 200°F with a temperature indicating marker. This QA Inspector reviewed Welding Procedure Specification (WPS) ABF-WPS-D15-1162-4, being used by QC and observed the welding appeared to comply with the contract requirements. This QA Inspector randomly observed QC Inspector Salvador Merino perform Magnetic Particle Testing (MT) on the root pass of the welding above. The overall length of welding was the length of the induction heating blanket, approximately 1,250 mm of the total 1,500 mm length of weld.
